LATERAL MENISCUS ZIP LESION

MÁRCIO L. DUARTE¹, ÉLIO V. DUARTE², ÉLCIO R. DUARTE³,
CLÁUDIA C. DUARTE⁴, ANA E. DUARTE⁵

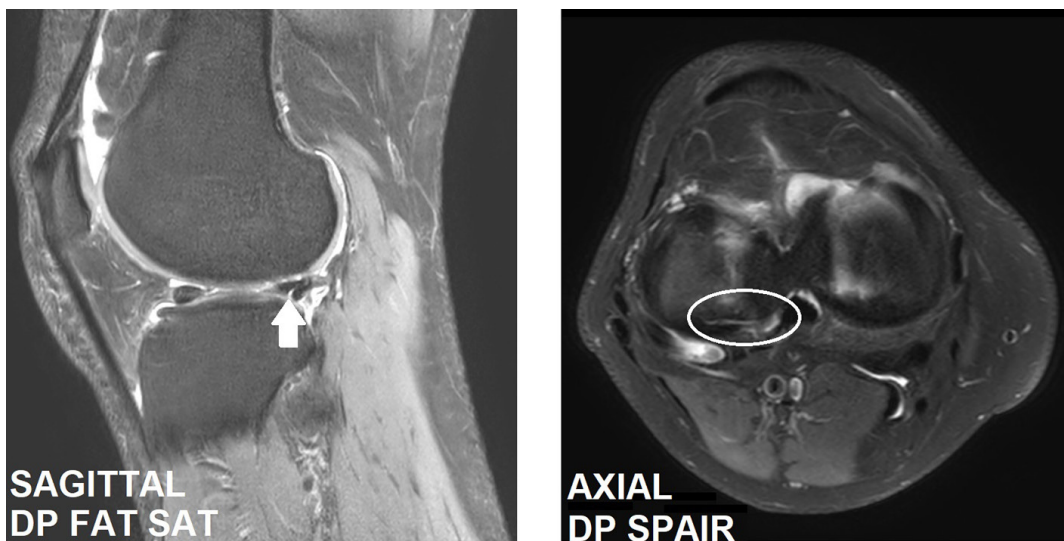
Figure 1 |

A 46-year-old man experienced right knee pain after a motorcycle accident, with no history of surgeries or other conditions. During a physical exam, he reported pain during the Appley and McMurray tests. His radiographs were normal. Magnetic resonance imaging revealed a longitudinal tear at the junction of the posterior horn of the lateral meniscus and Wrisberg's ligament, extending 1.7 cm in a mediolateral direction, consistent with a zip lesion (Fig. 1). Additionally, the MRI identified a complete tear of the anterior cruciate ligament (ACL) and a horizontal tear of the posterior horn of the medial meniscus. He was referred for arthroscopic surgery to repair these injuries.

In ACL tears, anterior tibial translation can cause the anterior part of the posterior horn of the lateral meniscus to shift forward, while the posterior section remains fixed due to tension on Wrisberg's ligament. This tension can create a longitudinal tear in the lateral meniscus, resembling a zipper, known as a "zip lesion" or "Wrisberg rip". These tears, located at the junction of the Wrisberg meniscofemoral ligament and the posterior horn of the lateral meniscus, must extend over 1.4 cm from the lateral edge of the posterior cruciate ligament to differentiate from a "Wrisberg pseudotear".
