AIR CRESCENT SIGN IN PULMONARY ASPERGILLOMA

MAXIMO ROUSSEAU-PORTALIS¹, INDALECIO CARBONI BISSO²¹Clínica Médica, ²Terapia Intensiva de Adultos, Hospital Italiano de Buenos Aires, Buenos Aires, Argentina

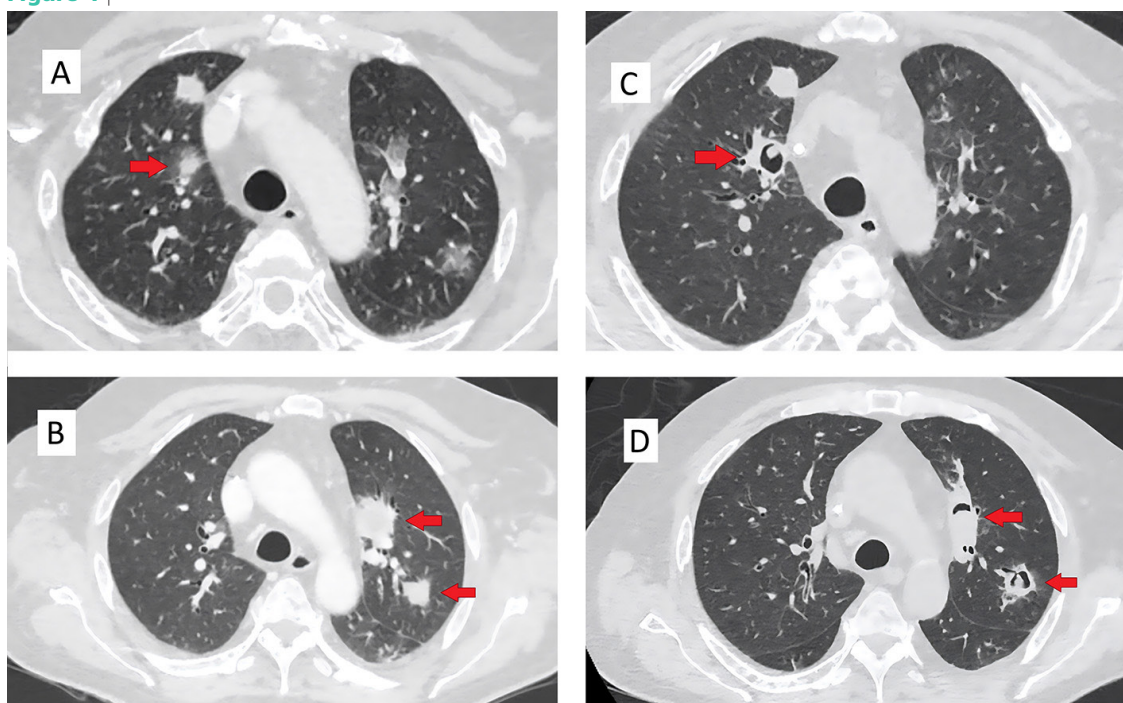
Figure 1 |

A 61-year-old man with plasma cell leukemia was hospitalized for dialysis-dependent renal failure after receiving chemotherapy with cyclophosphamide, bortezomib, daratumumab, and dexamethasone. During a profound neutropenic fever, chest CT showed multiple bilateral pulmonary nodules surrounded by ground-glass opacity—the halo sign—compatible with early angioinvasive fungal infection. Bronchoalveolar lavage galactomannan and blood polymerase chain reaction was positive for *Aspergillus* spp., confirming the diagnosis of invasive pulmonary aspergillosis. Targeted antifungal therapy was initiated (Fig. 1 A and B). As neutrophil recovery occurred, a follow-up CT

demonstrated transformation of the nodules into thick-walled cavities with heterogeneous intracavitary material and a characteristic air crescent sign. In angioinvasive fungal infection, pulmonary nodules represent areas of infected, hemorrhagic, and infarcted lung tissue; during immune recovery, reabsorption of necrotic tissue causes central retraction of the infarcted core, allowing air to accumulate between the cavity wall and the necrotic center. This process generates the air crescent sign, typically observed in the recovery phase of invasive aspergillosis and considered a favorable prognostic indicator, occurring in approximately half of patients (Fig. 1 C and D).
